# Vessels Detained in China - 2014

# Port State Control Trending

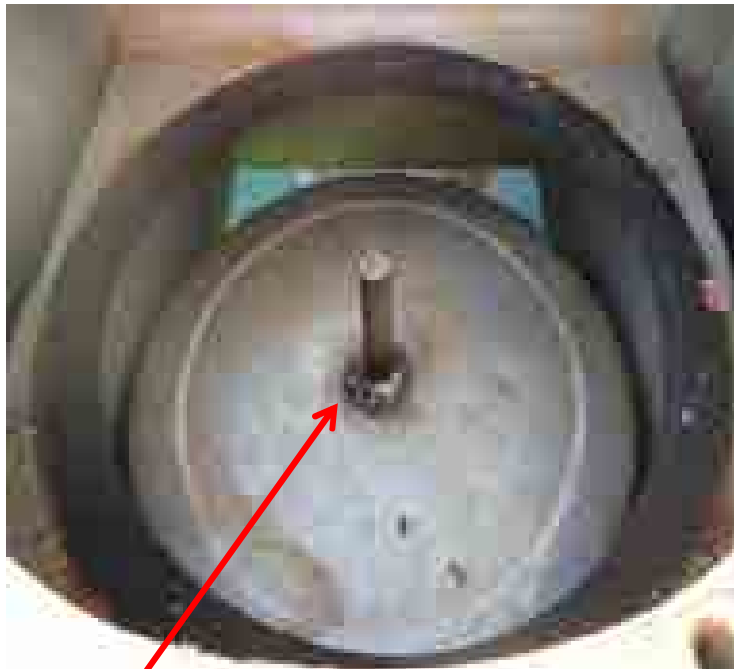
# WBT Air Vent Head Float Defect

**Float and Spindle weld connection**

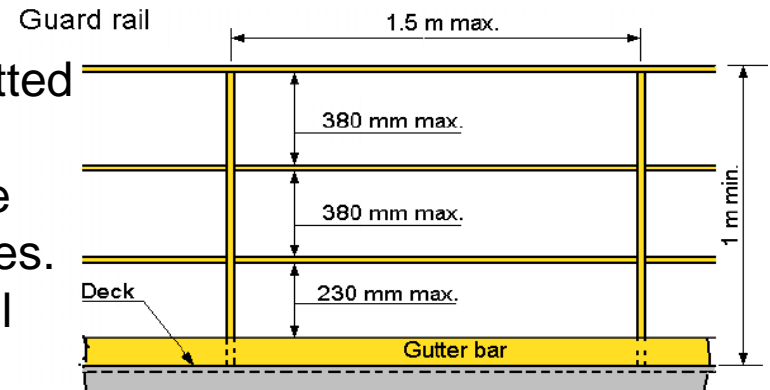
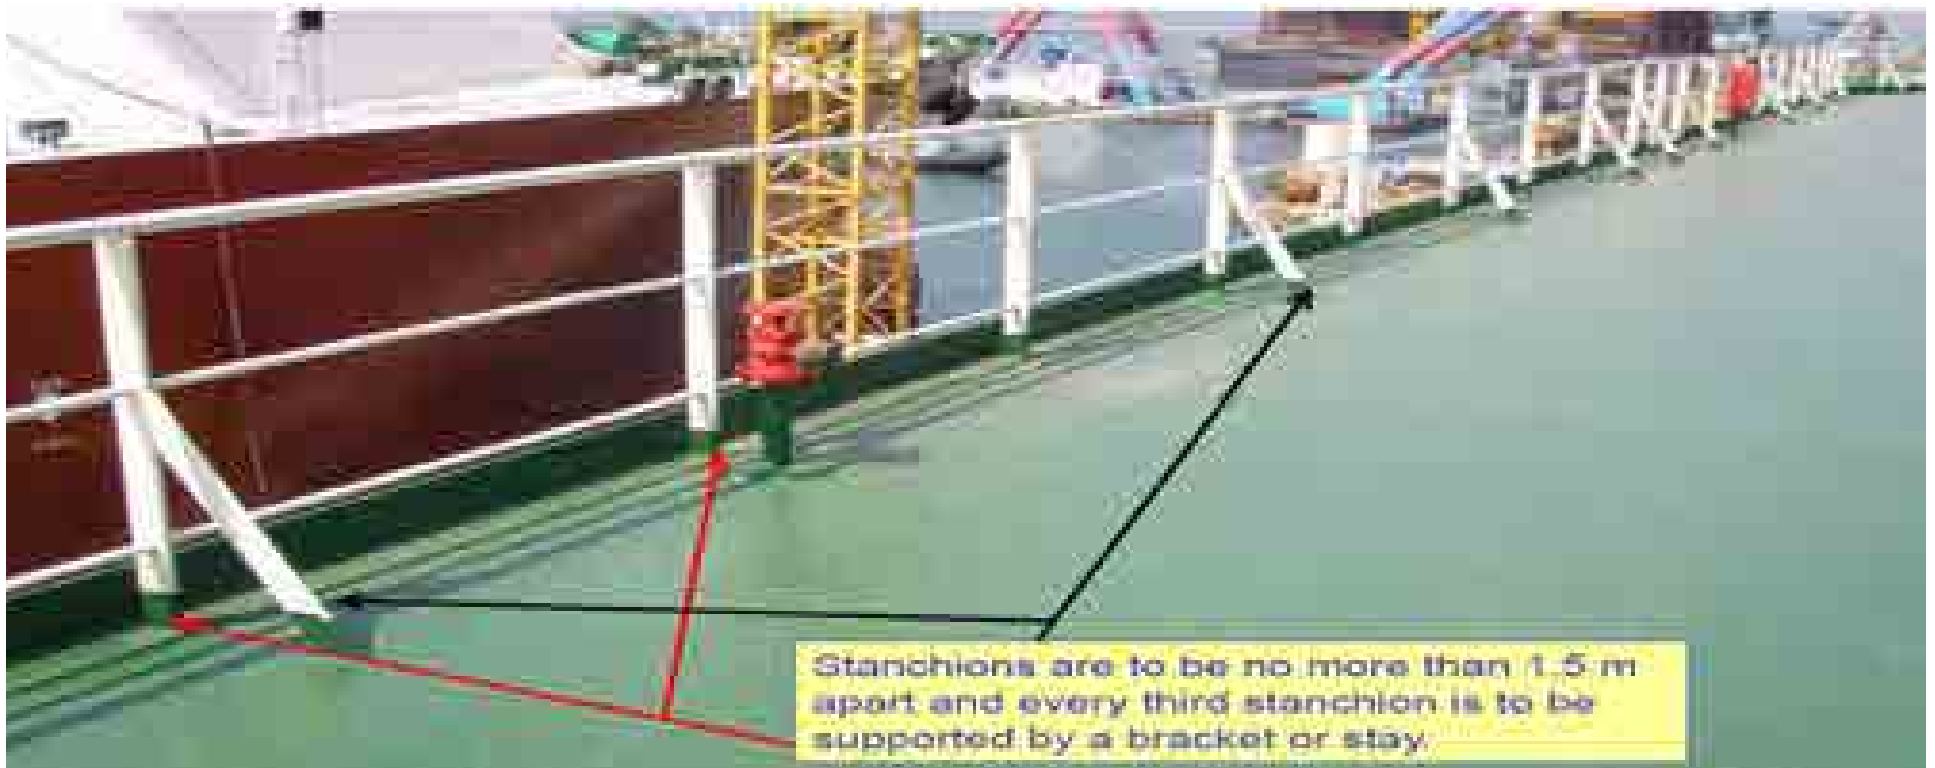
GUARDRAILS STANCHIONS OF  
GUARDRAIL ON BRIDGE DECK  
AFT NOT BE SPECIALLY SUPPORTED  
AT EVERY THIRD STANCHIONS

1	07/03	GUARDRAILS ON POOP DECK SAME STANCHIONS NOT BE SUPPORTED AT EVERY THIRD STANCHIONS
---	-------	---

Regulation 25(2): Guard rails or bulwarks shall be fitted around all exposed decks.

Regulation 25(3): Guardrails fitted on superstructure and freeboard decks shall have at least three courses.

Regulation 25(3b): At least every 3rd stanchion shall be supported by a bracket or stay.

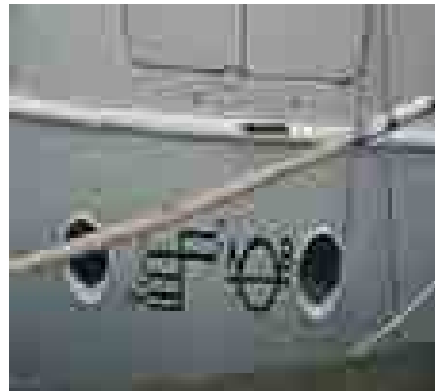
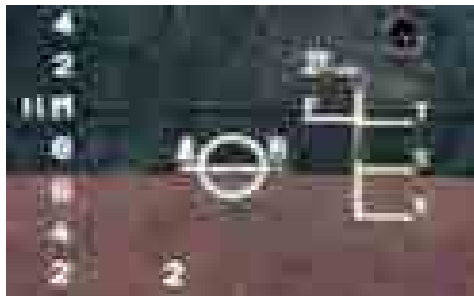
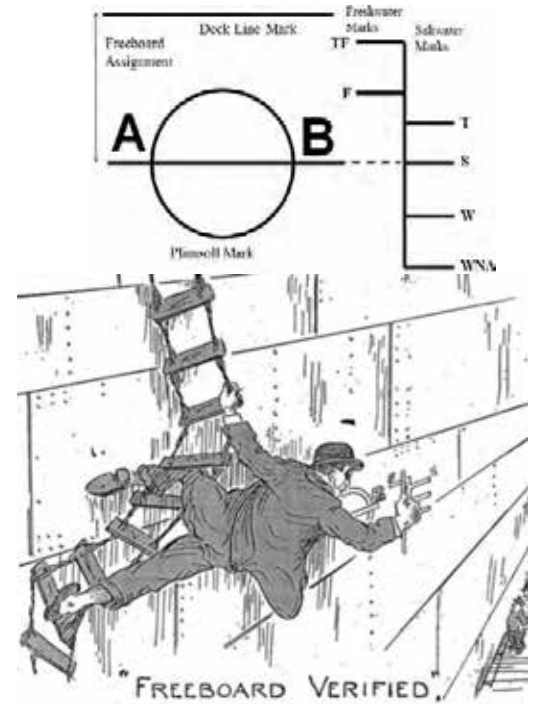
1	03102	LOAD LINE MARK NOT CLEAR	16
2	03102	DRAFT MARK ON SHIP'S HULL FADE OUT	16
01	03115	THE BOW DRAFT MARK NOT AVAILABLE

1 03102 Two sets of load line marks on ships side. 17

PORTSIDE DECK LINE MARK FADED 17/10

1 03102 STBD FREEBOARD MARK NOT CLEARLY 17

| 1 | 03199 | THE LOAD LINE MARK AND FRESH WATER LOAD LINE (NOW USED) WAS NOT PERMANENTLY MARKED ON SHIP SIDE. | reference ⑤<br>taker<br>17 |
| 2 | 03199 | THE PERMANENTLY LOAD LINE MARK (UPPER ONE) WAS NOT PAINTED PLAINLY VISIBLE. | 17. |

At Annual LL Surveyor Surveyor to confirm: The freeboard marks are to be sighted, found plainly visible, and recut and/or painted in accordance with the LL Certificate as required. The LL Certificate is to be examined for accuracy.

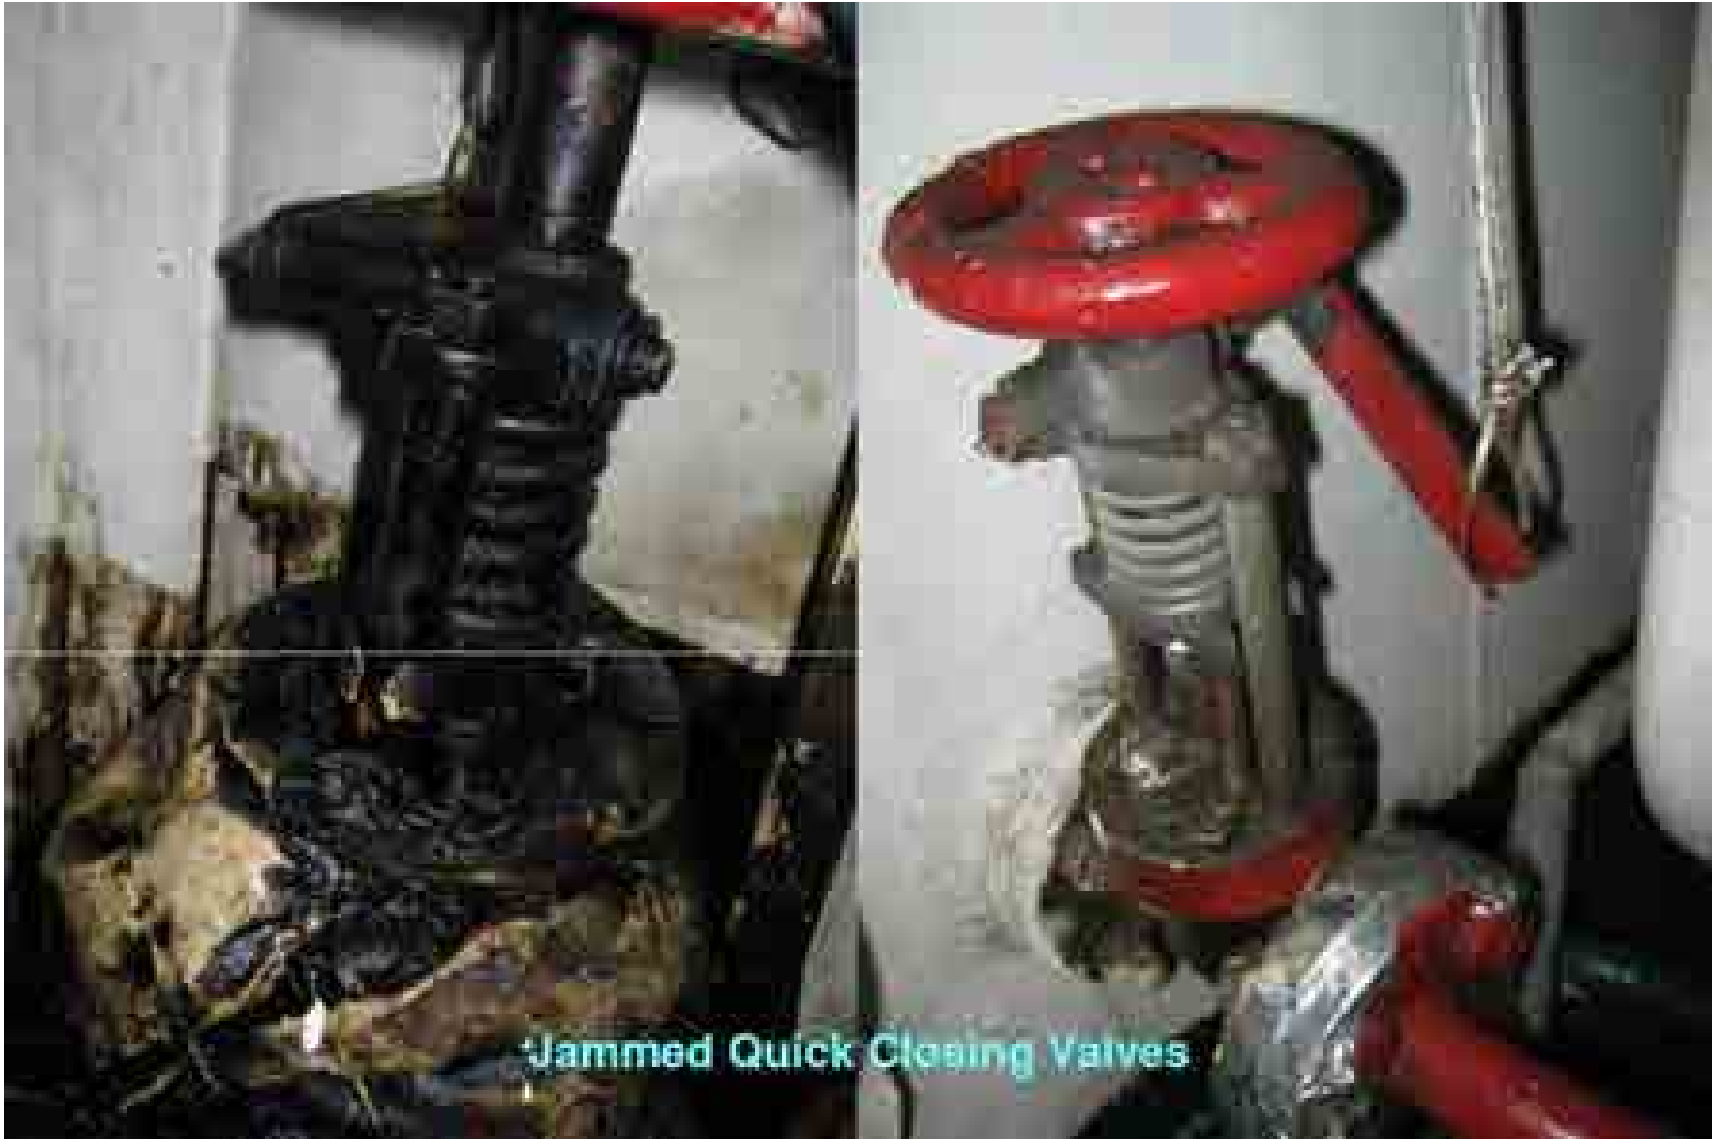
Jammed Quick Closing Valves

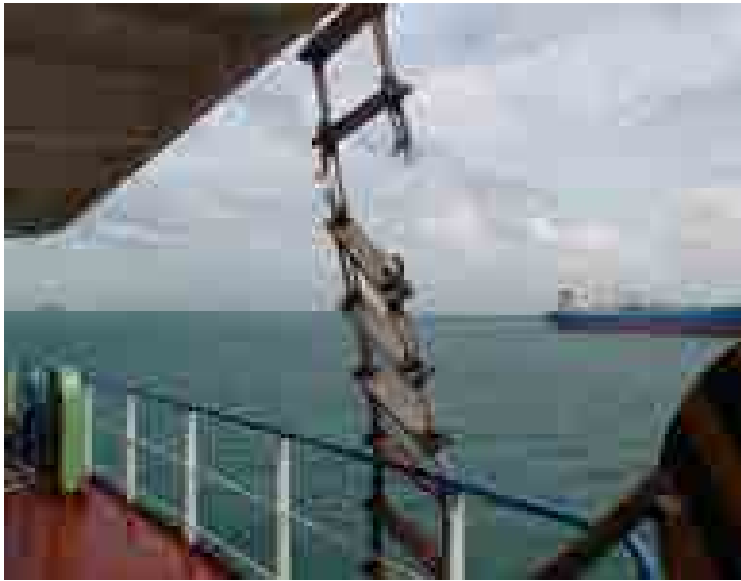
◀ 2008 built chemical carrier

# Embarkation Ladder Damage

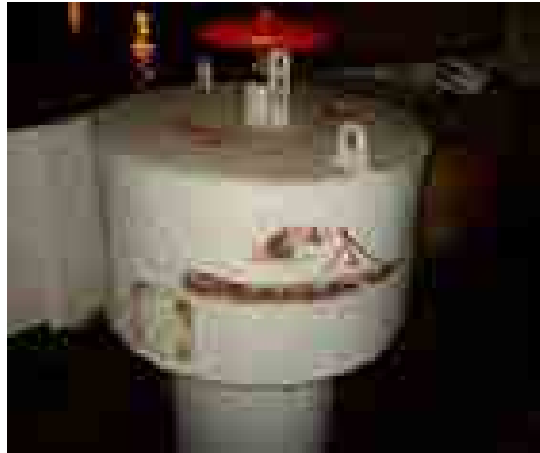
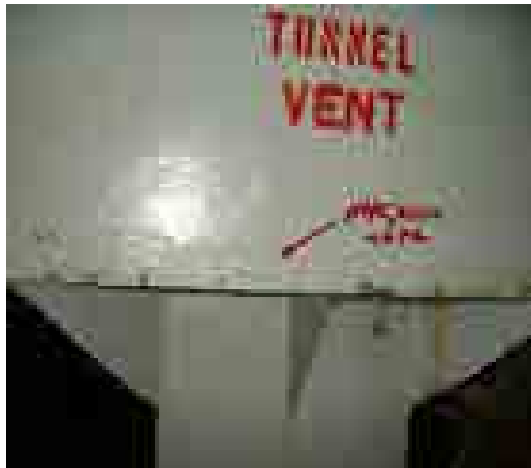
Ventilator casings holed  
Fire flap wasted/broken

Examination of the closing arrangements of openings in funnels, skylights, ventilators, doorways and tunnels. Ventilator ducts are to be opened to verify satisfactory condition and operation of dampers.

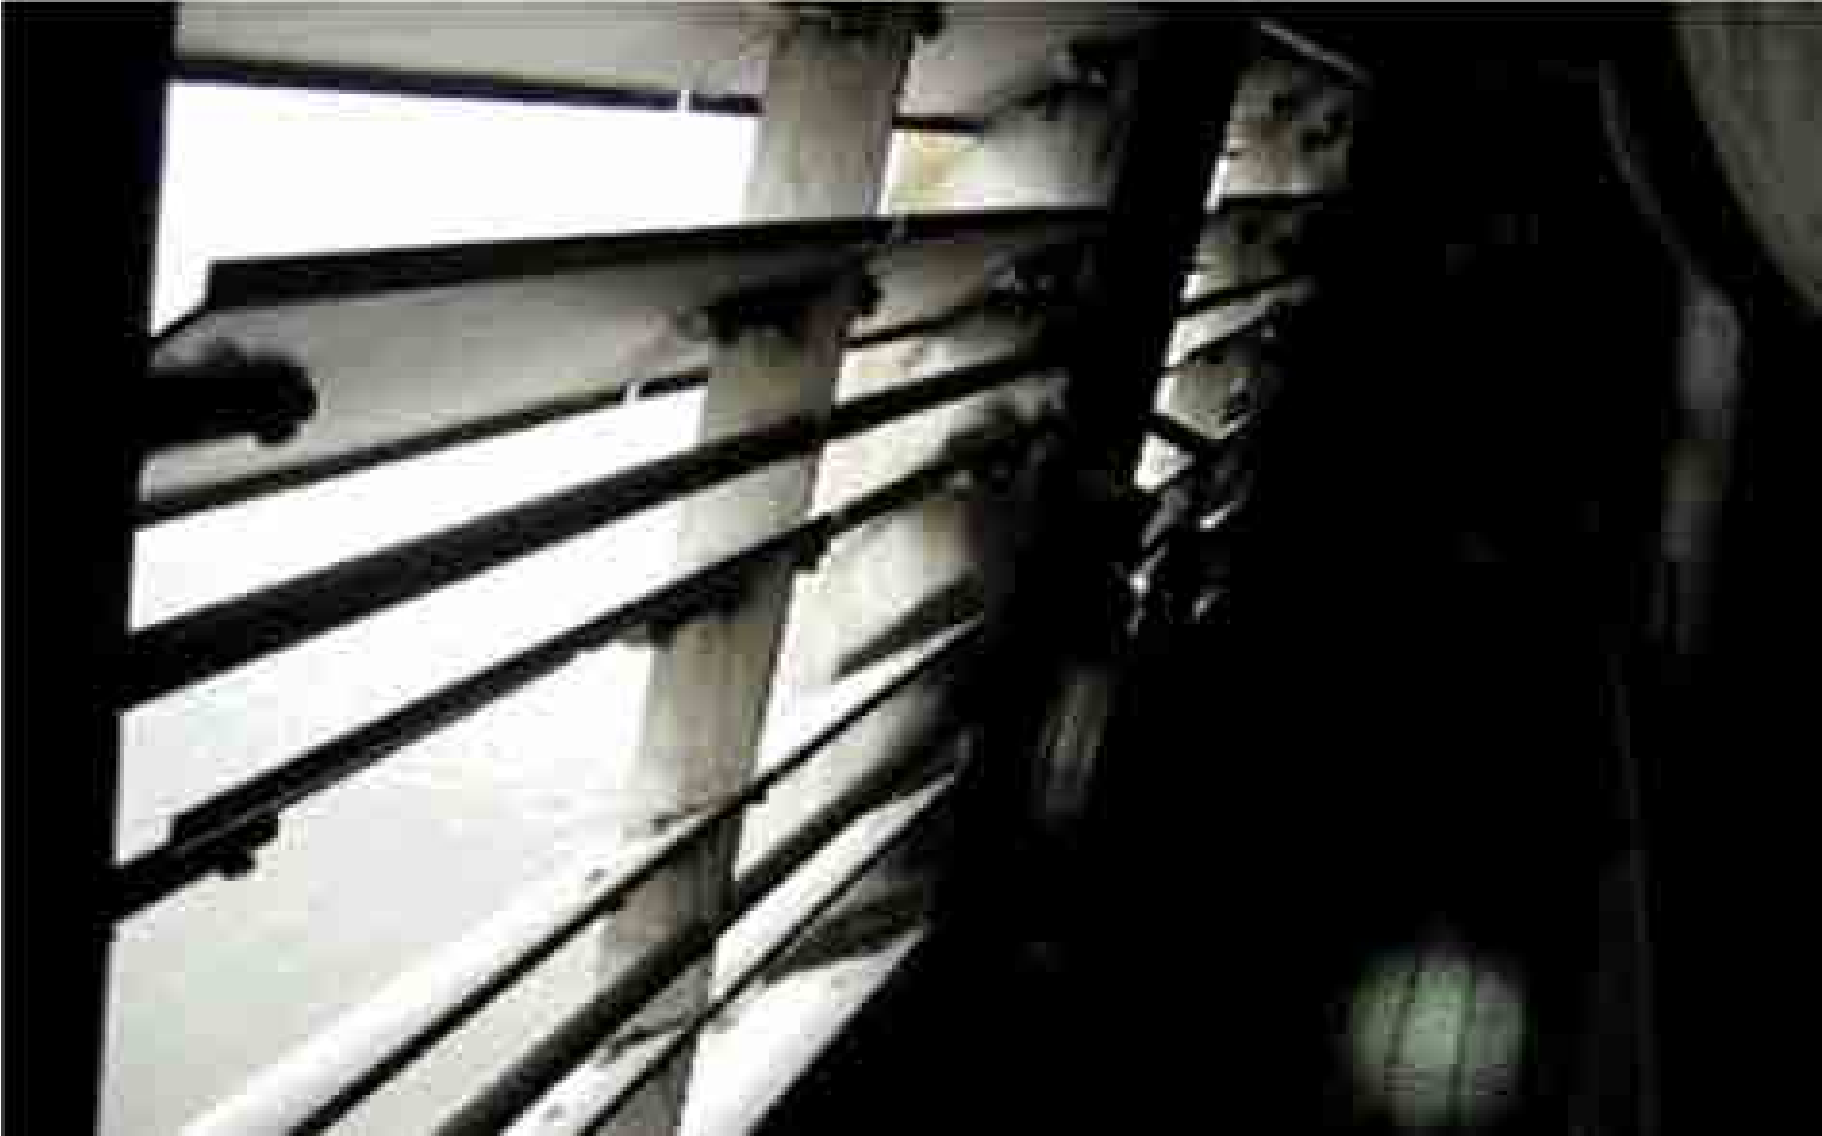
20 number	21 code	nature of deficiency <sup>4)</sup>	Convention <sup>5)</sup> references	22 action taken <sup>6)</sup>
1	07115	FIRE DAMPER OF FUNNEL CANNOT BE CLOSED TIGHTLY		30

# Funnel Flaps – Any Problem??

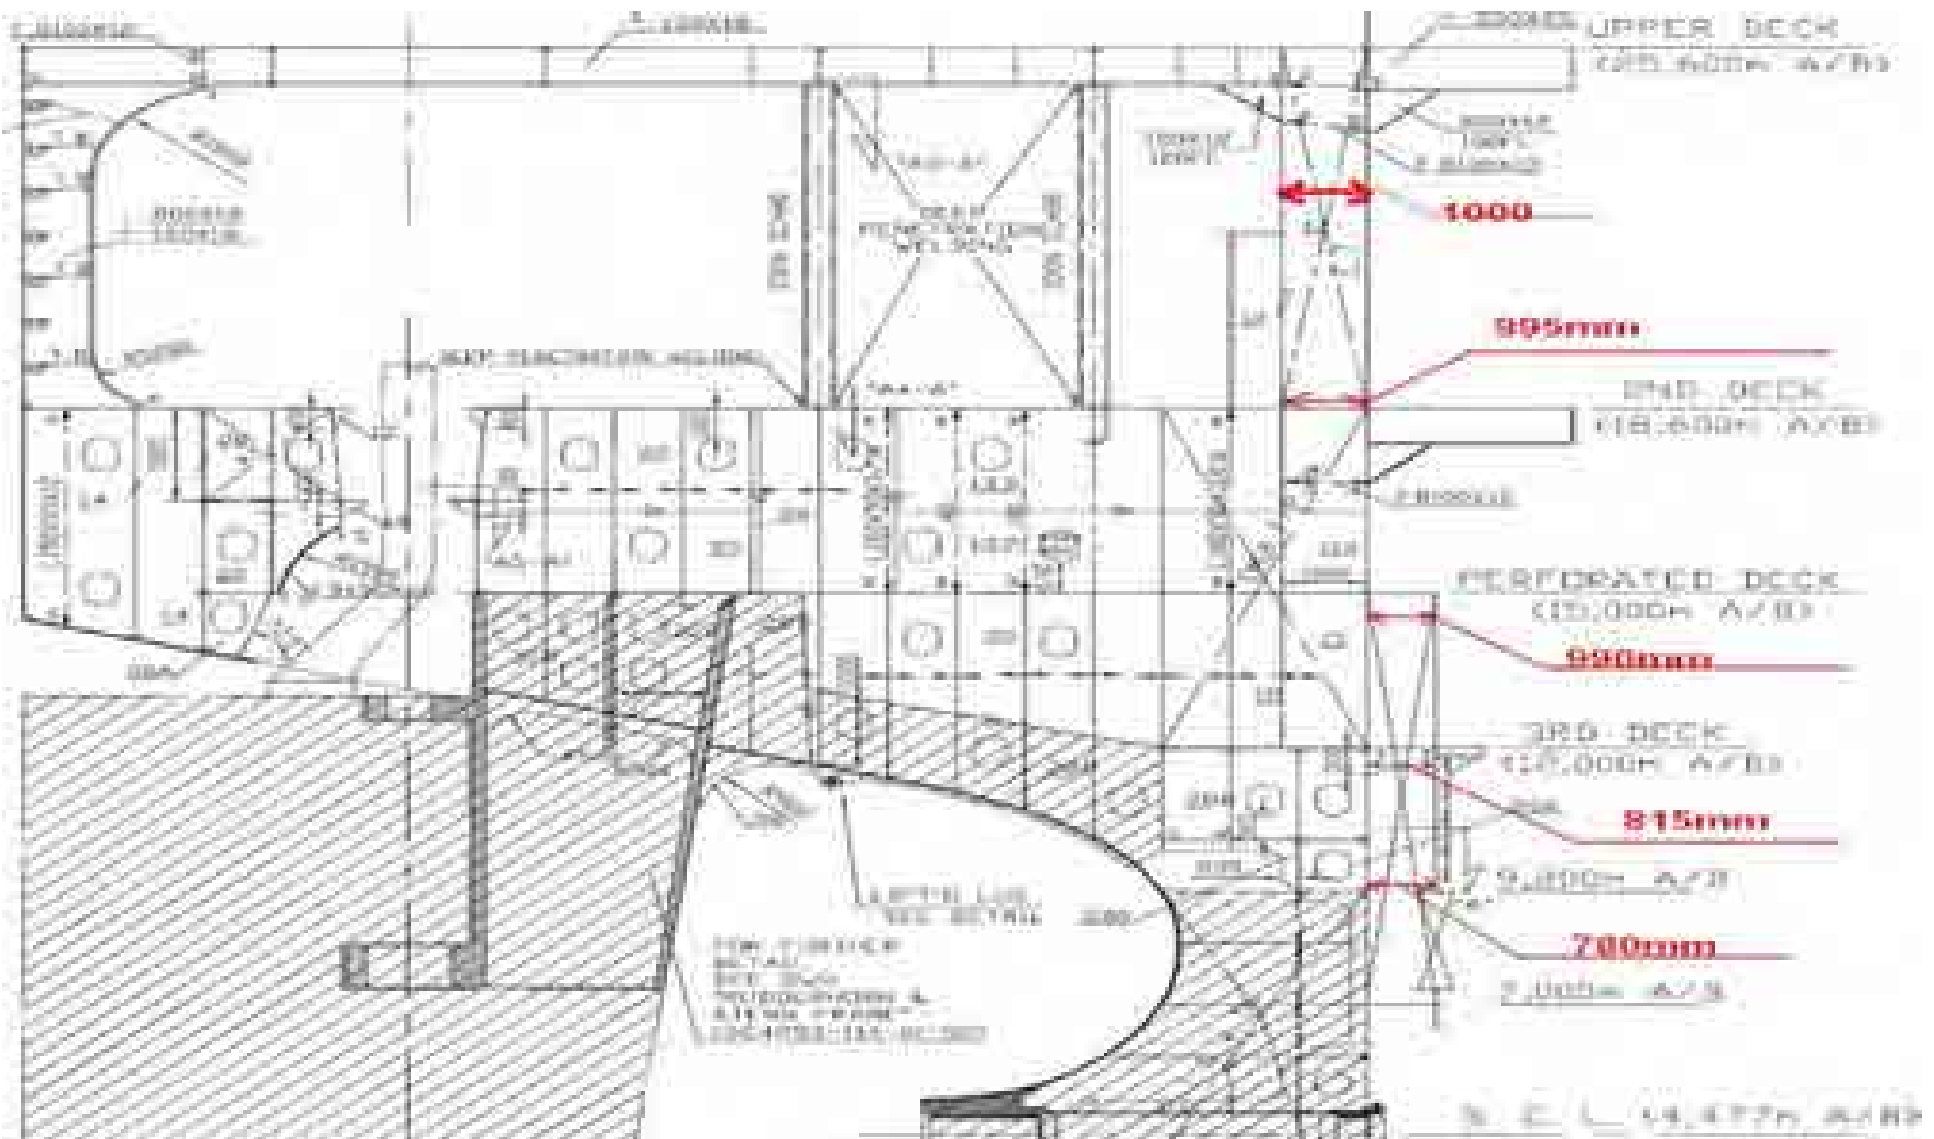
# PSC Detention 17/06/14 – ER Emgcy Escape Trunk

20 No.	21 code	nature of deficiency ④	convention reference ⑤	22 action taken ⑥	23 responsible RO ⑦
07120		HEAT CAN BE TRANSFERRED INTO ENCLOSURE OF E/R EMERGENCY ESCAPE TRUNK THROUGH NON-INSULATED FIXING POINTS.	S74-24/CII-2/R13.4.2.1	30/10	YES

**SOLAS Chapter II-2 Regulation 13.4.2.1.1 clearly states; “the ladder shall be fixed in such a way that heat is not transferred into the enclosure through non-insulated fixing points”.**

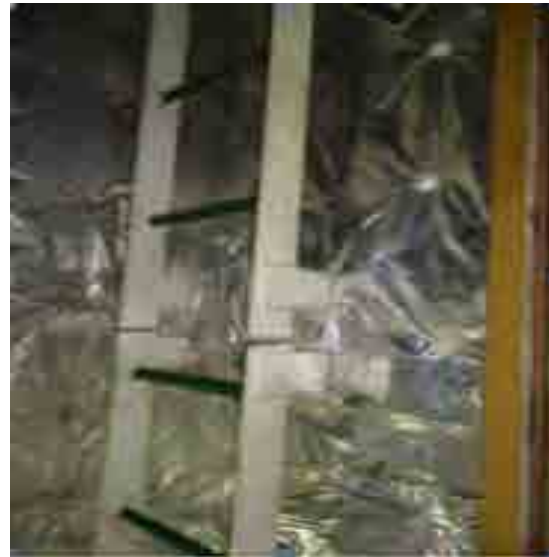
- ABS Approved Insulation Drwg clearly shows that the A-60 insulation in-way-of the bulkhead to which the ladder is attached is mounted externally.

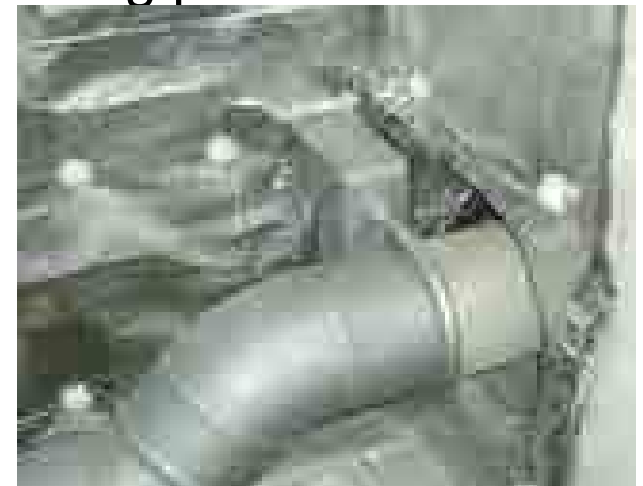
- Example: The photo is of a CO<sub>2</sub> pipe in the control room, which is fully insulated to A-60, except for the attached bracket. China MSA PSC Inspector did raise this as a deficiency citing SOLAS Chapter II-2 Regulation 13.4.2.1.1 ABS Engineering position is that:-

**“With regard to fire insulation of pipe support brackets, SOLAS II-2/9.3.4 and its interpretation in MSC/Circ.1120 does not explicitly require non-structural items attached to insulated decks or bulkheads to be insulated, and as the attachment area is small and the supports are partially insulated, the heat transmitted along the support would be absorbed by the insulation”.**

- **Discussed result by Port State Control Sub-committee of China MSA:** For this case, SOLAS II-2/9.3.4 and its interpretation in MSC/Circ.1120 does not explicitly require non-structural attach to insulated decks or bulkheads to be insulated. The original regulation is “In approving structural fire protection details, the Administration shall have regard to the risk of heat transmission at intersections and terminal points of required thermal barriers”. This is an ambiguous point. Whether raise deficiency or not always depends on the professional judgement of PSCOs. Discussing and communicating with PSCOs fully is always helpful. The unified guidance made by China MSA on this deficiency is not practical.

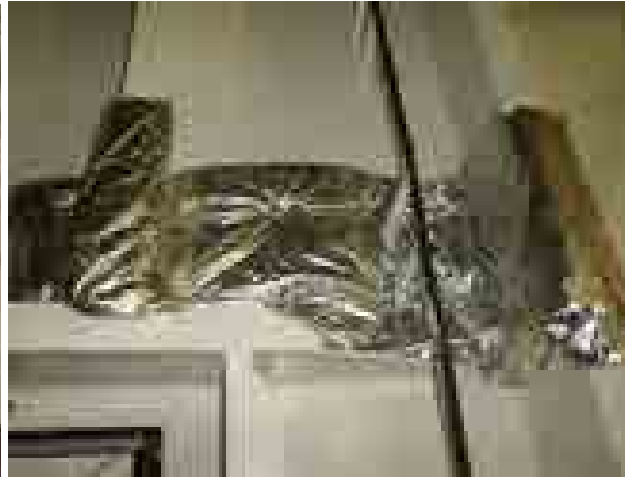
Inside brackets are fully covered with A-60 covering.

The ladder supports are covered with A-60 covering from outside.

Q5. In cases where the insulation was only placed on the inside of the emergency escape trunk, does the below modification where A-60 is now placed externally in-way-of the ladder fixing points satisfactorily address this PSC deficiency?
