# Vessels Detained in China - 2014

# Port State Control Trending

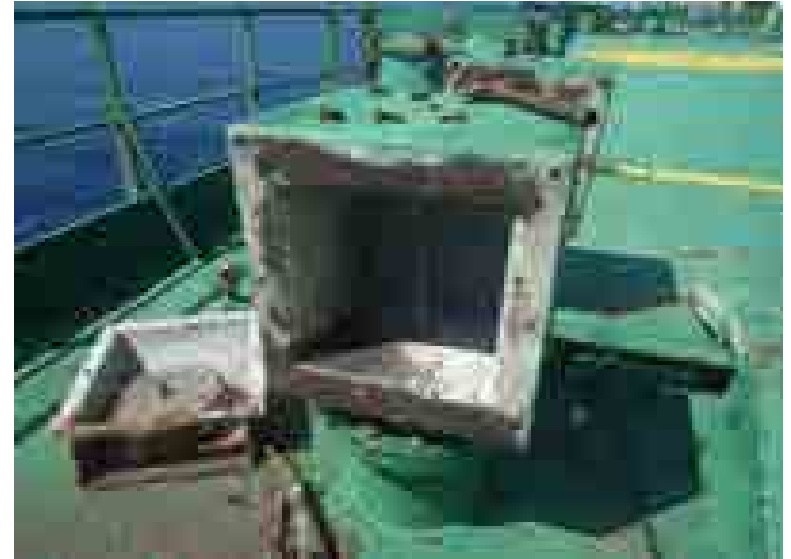
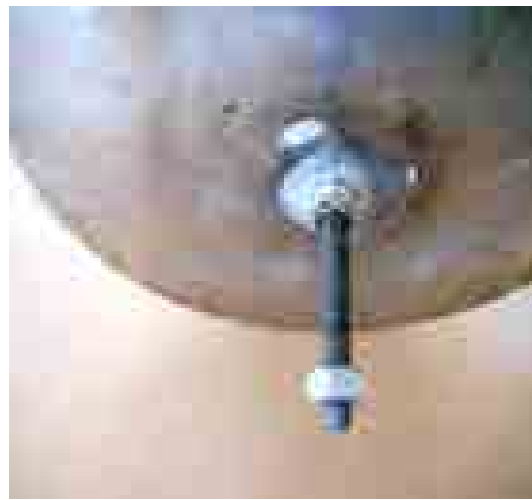
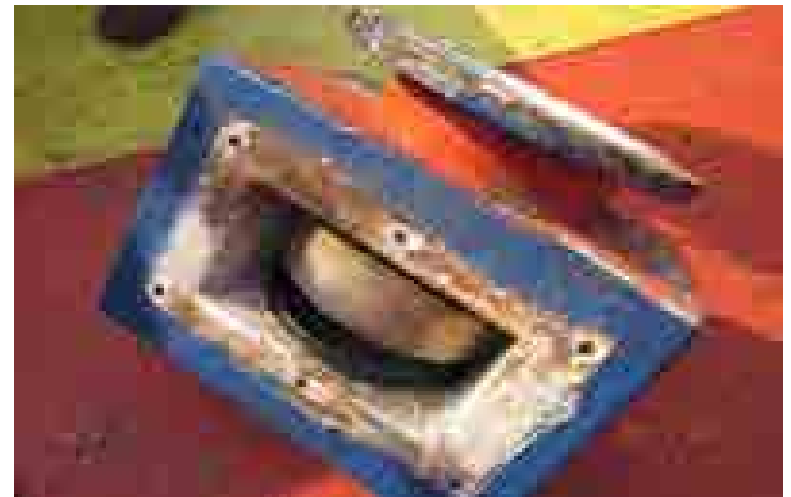
# Air Pipes

- At each Annual Hull Survey, air pipe closure devices are to be **randomly** opened and their condition verified
- At each Special Survey of Hull, **all** air pipes are to be opened and examined both internally and externally

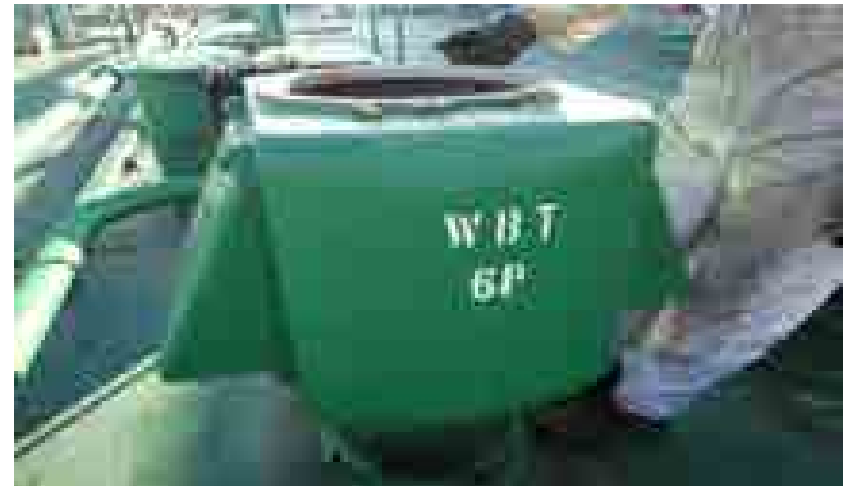
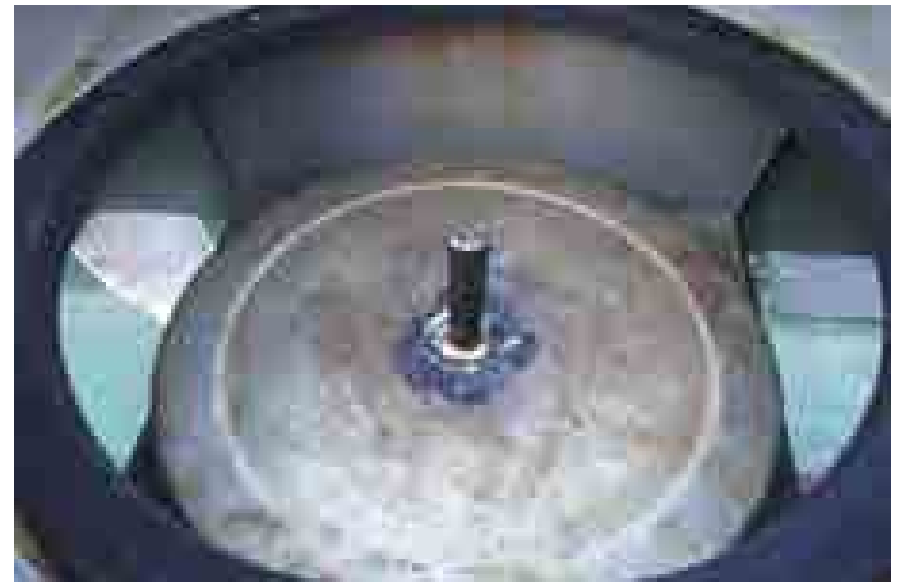
# WBT Air Vent Head Float Defect

**Float and Spindle weld connection**

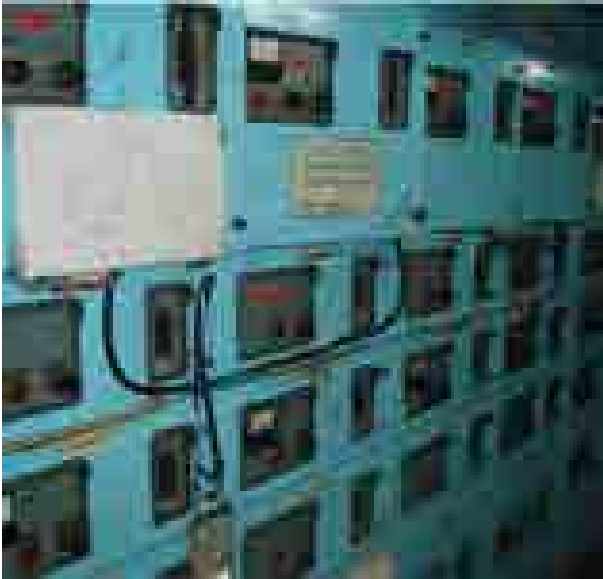
Jammed Quick Closing Valves

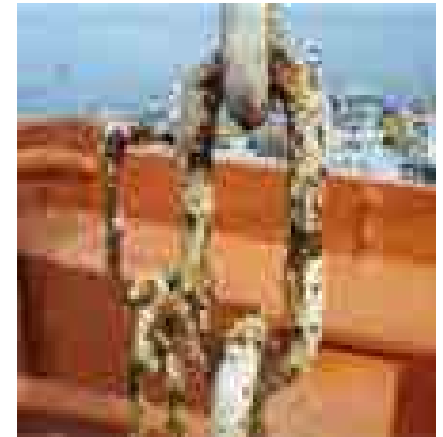
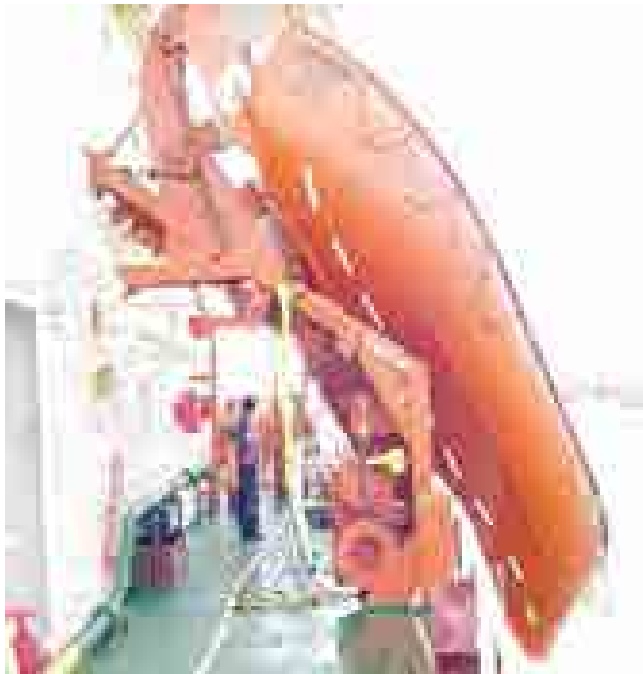
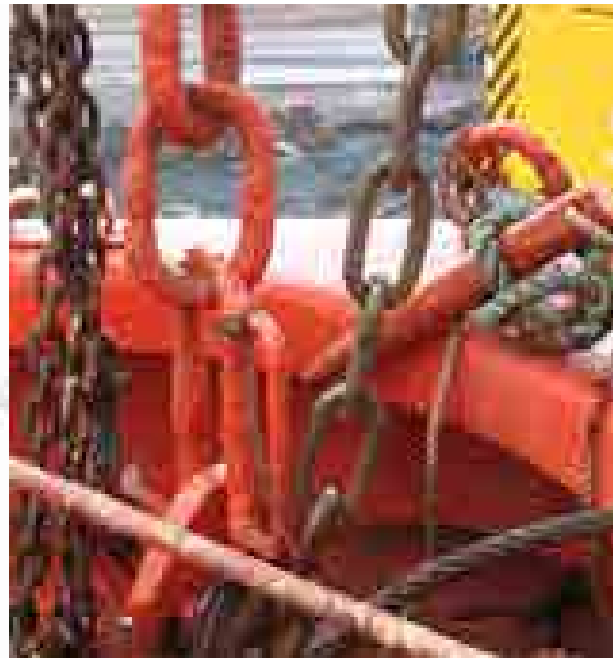
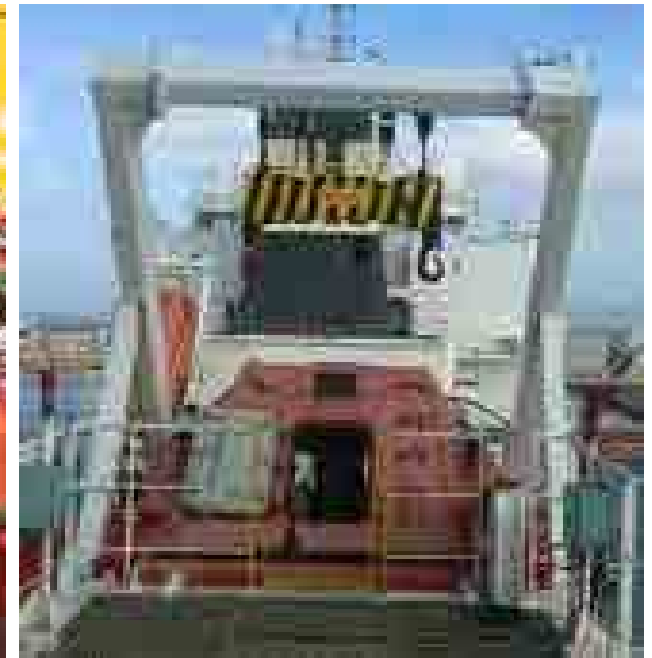
# Lifeboats & Launching Appliances

Lifeboats & equipment are a major issue with Class & PSC

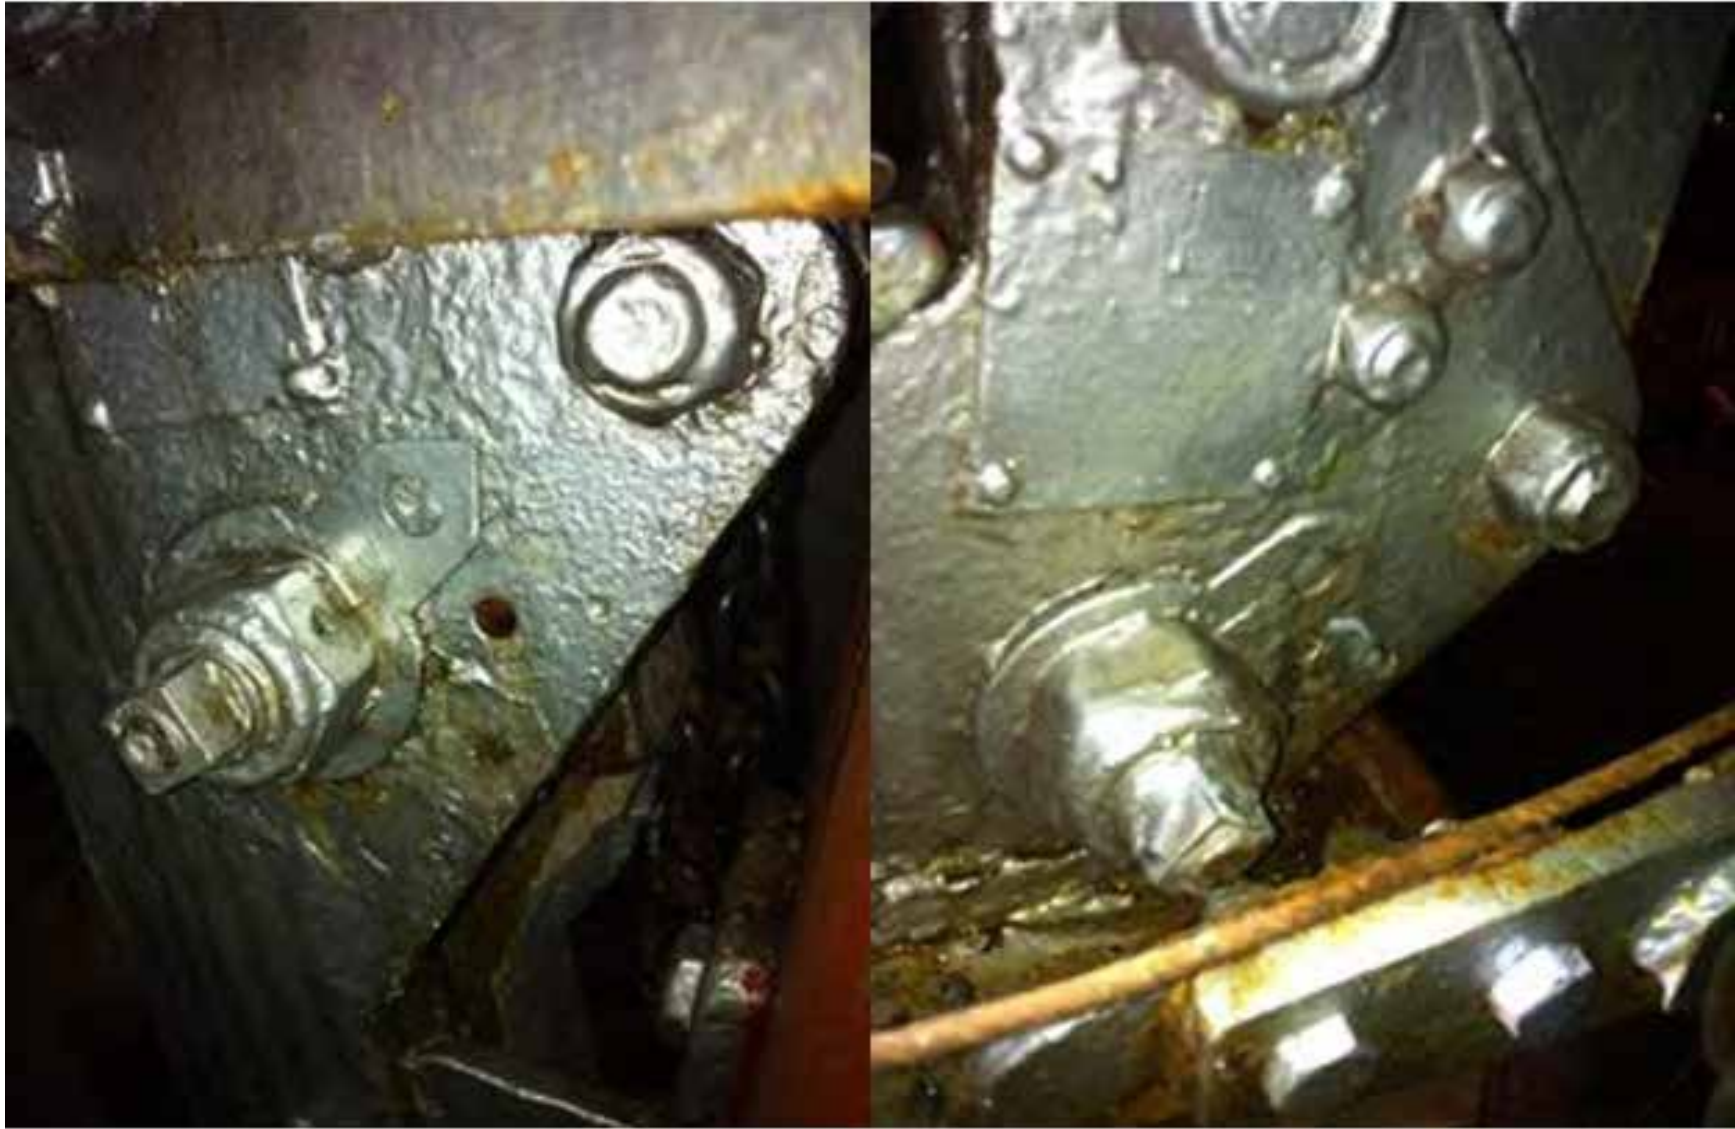
## Hook indicator position – external

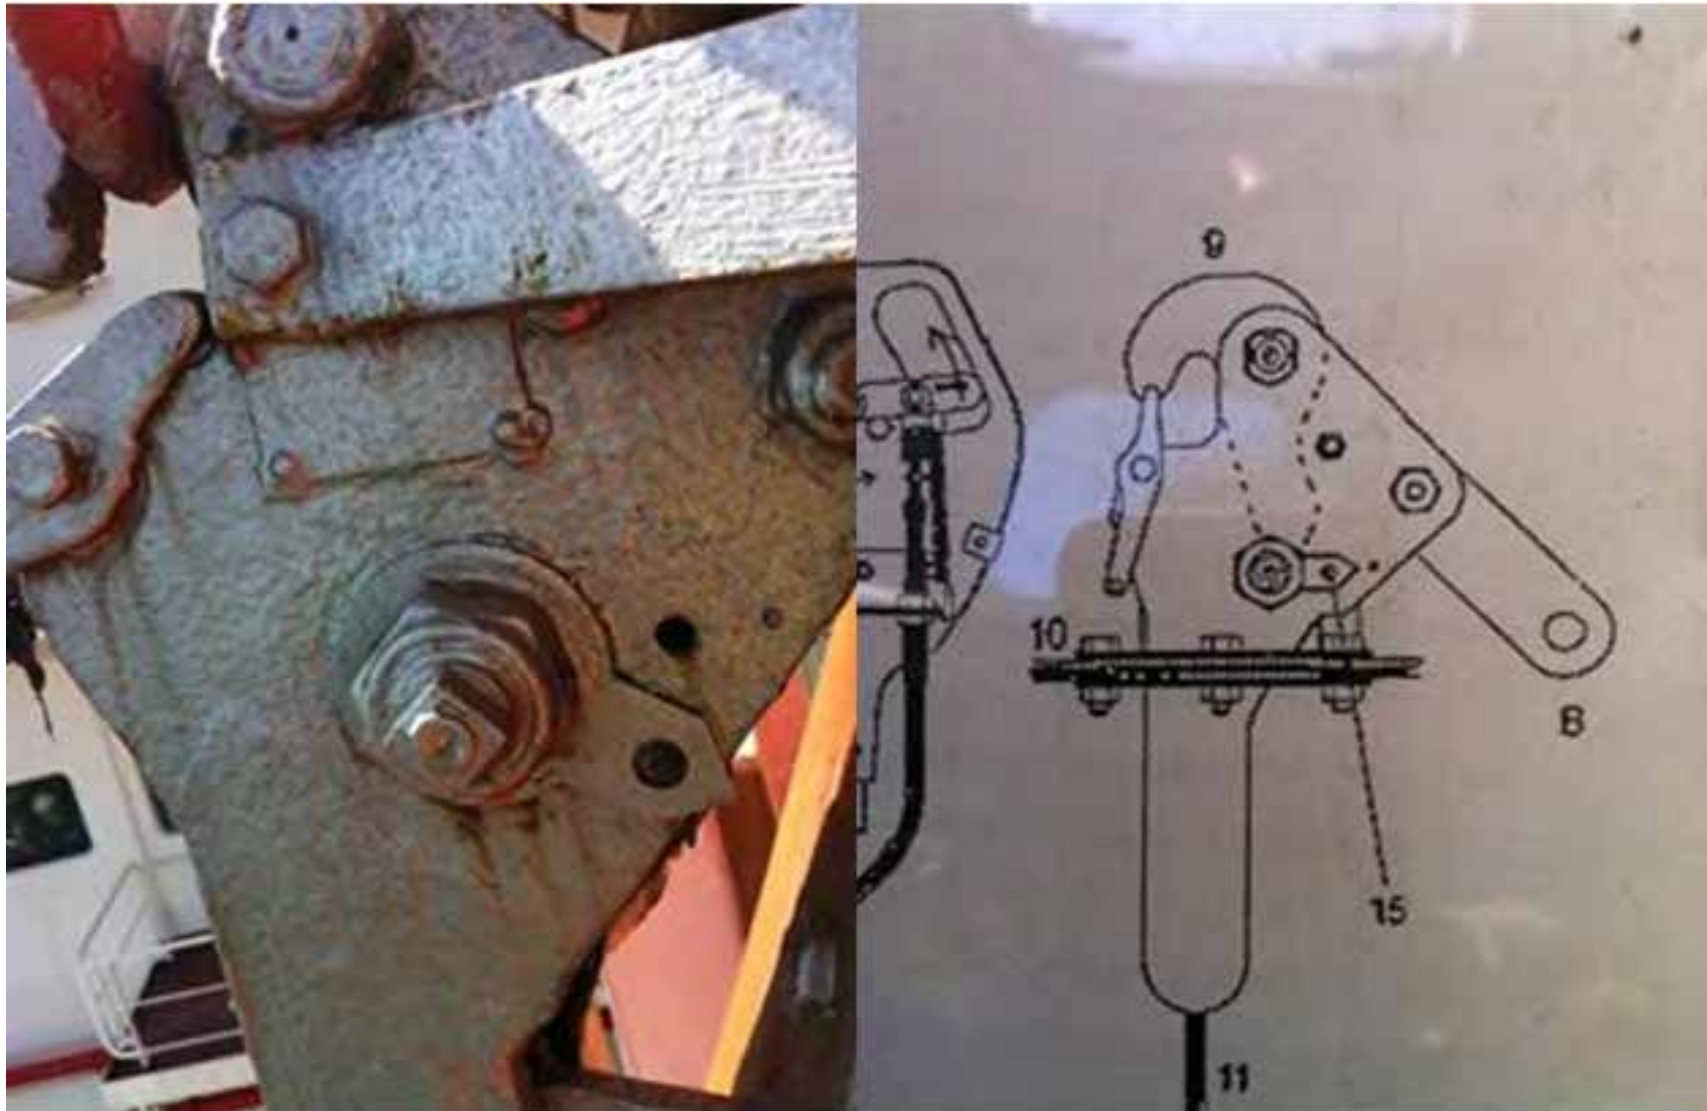
## Hook indicator position – external

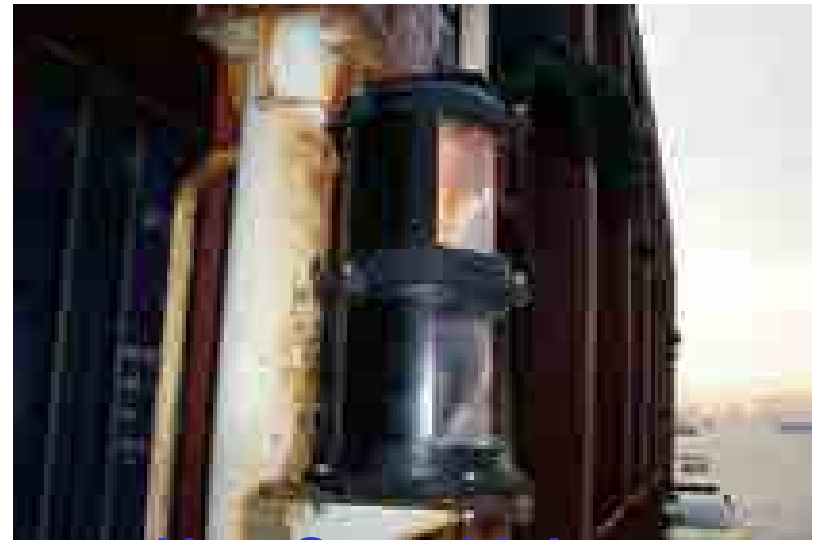
- 1998 built container carrier was detained due to:
  - Horizontal arc of visibility of stern light found not as per COLREG
- This is the 2<sup>nd</sup> time that a vessel has been detained for this deficiency

**Existing Stern Light**

**New Stern Light**

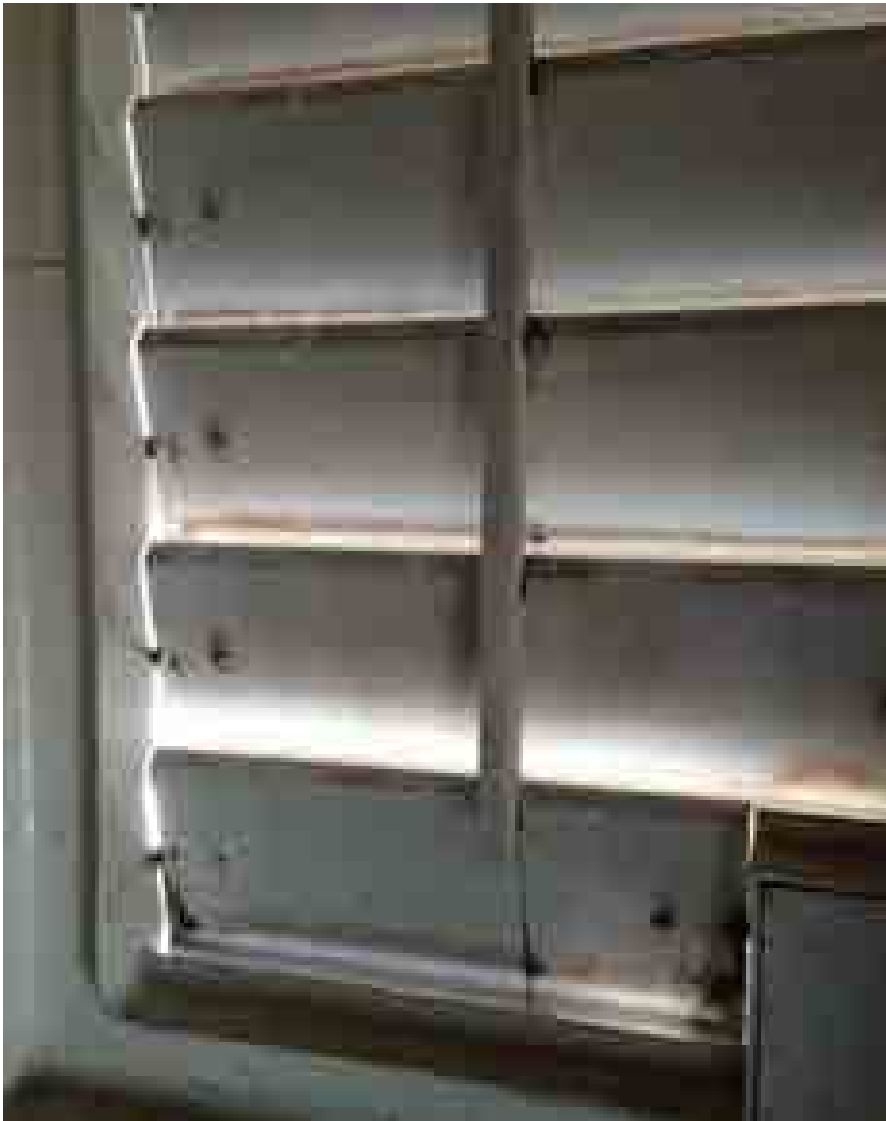
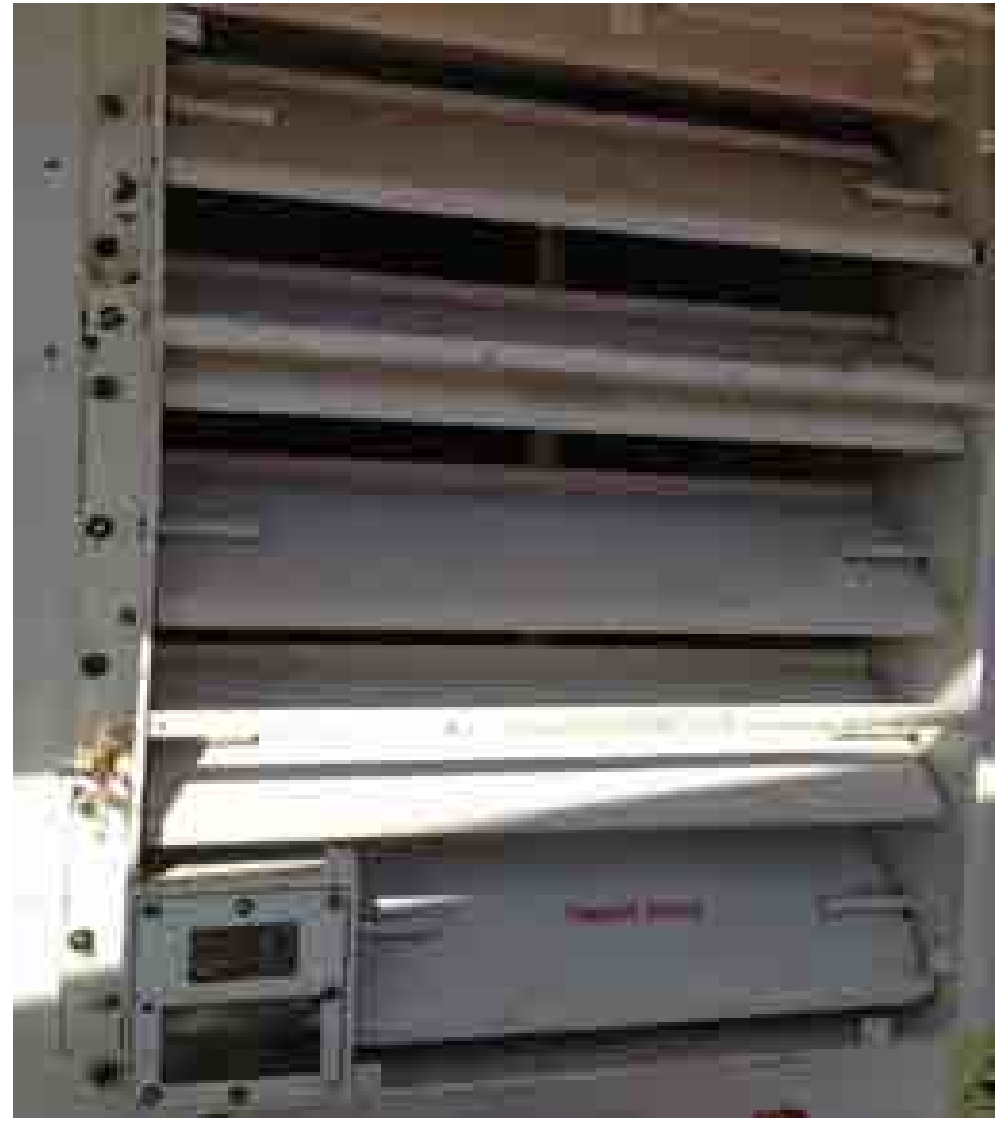
# Typical funnel louvre dampers/flaps

- PSC have detained several vessel's in China in 2013,2014 & and now in 2015, due to the operation of engine room & funnel dampers. Typical deficiency reported has been:
  - i) Fire damper has gap.
  - ii) Fire damper cannot close tightly.
  - iii) Fire damper cannot close from outside.

- 1. As per section 4-7-2/1.9.6 of the SVR's and SOLAS Reg. II-2/5.2.2.1 "means of control are to be provided for closure of **openings in funnels which normally allow exhaust ventilation and closure of ventilation dampers**".
- 2. There are **NO** requirements for the dampers located in the engine room funnel to be either **gastight or watertight** (normally these dampers are located higher than 2.3 m above position 2 and accordingly they **are not required to be watertight** in accordance with Load Line requirements).

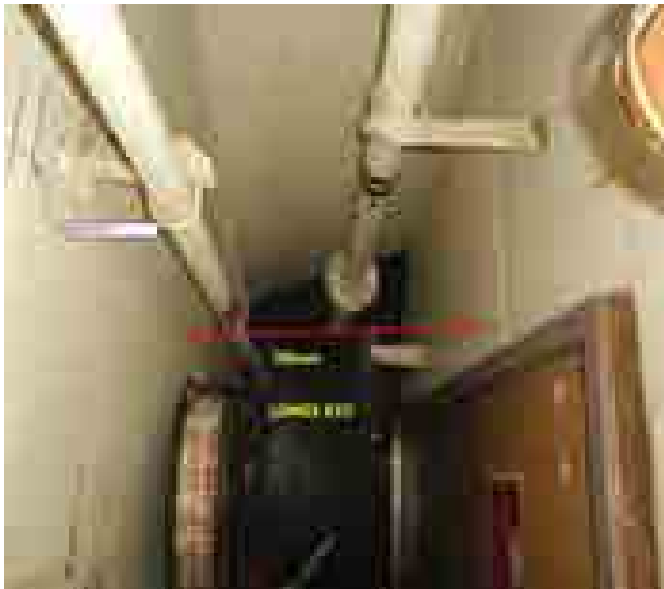
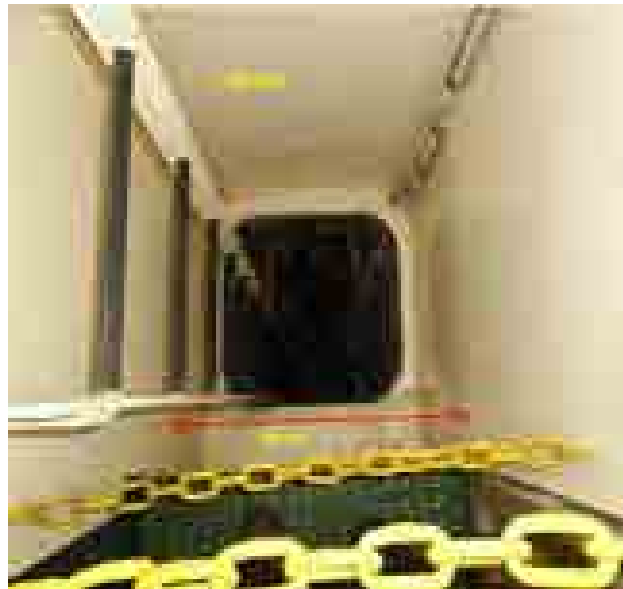
- Vessel detained (Code 30) by China PSC in Lianyungang.
- **ABS held responsible i.e. are BLAMED.**
- PSC Rejects ABS Appeal

07120 LENGTH OF EMER. ESCAPE  
TRUNK IN E/R NOT REACHED  
TO 800 AM. S74-21/SI-4/26/A 30/70/99 (DRY DOCK)

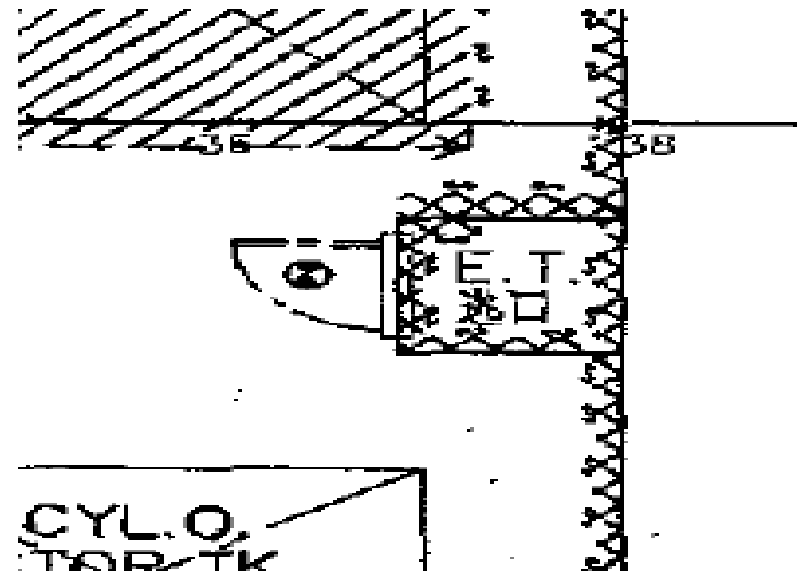
20 No.	21 code	nature of deficiency ④	convention reference ⑤	22 action taken ⑥	23 responsible RO ⑦
07120		HEAT CAN BE TRANSFERRED INTO ENCLOSURE OF E/R EMERGENCY ESCAPE TRUNK THROUGH NON-INSULATED FIXING POINTS.	S74-24/CII-2/R13.4.2.1	30/10	YES

- ABS Approved Insulation Drwg clearly shows that the A-60 insulation in-way-of the bulkhead to which the ladder is attached is mounted externally.

Since the approved drwgs were not followed during the new construction, the appeal to the PSC Inspector was unsuccessful.
